Car Stereo
Service Bulletin

Model: CDX-5040

No. 206

Subject: No Operation

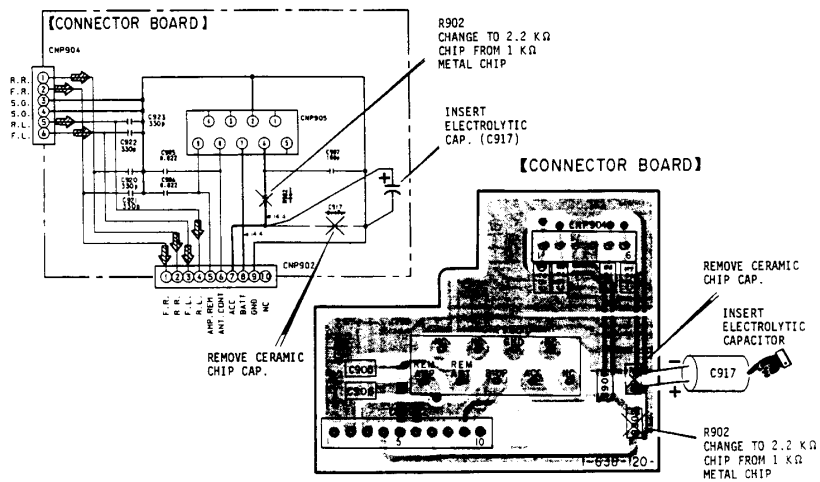
Symptom: (11) The unit does not turn on when the ignition key is turned to "ON" or "ACCESSORY".

Solution: Replace the following parts on the connector board:

REF.	FORMER		NEW	
	Description	Part No.	Description	Part No.
R902	RESISTOR, METAL CHIP 1K Ω 5% 1/8 W	1-216-198-00	RESISTOR, CHIP 2.2K Ω 1/10 W	1-216-057-00
C917	CAPACITOR, CERAMIC CHIP 0.47 μ f 16V	1-162-637-11	CAPACITOR, ELECT. 0.47 μ f 50V	1-126-159-11
