Car Stereo Service Bulletin

Model: CDX-5040/5080/7520/7540/7560/7580

No. 222

Subject: Service Manual Correction: PLL Free Run Adjustment

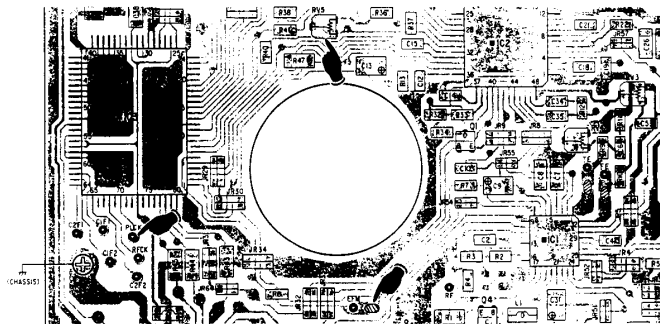
[RF BOARD]

The PLL adjustment shown in the Service Manuals is incorrect.

1. Do not insert the test disc.
2. Remove the solder bridge at test point EFM.
3. Connect a frequency counter to test point PLCK.
4. Press the power button.
5. Test mode setting:
 - a. For microcomputer IC501 μ PD75516GF-107-3BQ: Press the RESET button while keeping the MUTE and the 1 keys on.
 - b. For microcomputer IC501 μ PD75516GF-160-3BQ: Press the RESET button while keeping the MUTE and LOUD keys on.
6. Press the PLAY button.
7. Adjust RV5 for 4.3218MHz \pm 0.01MHz on the frequency counter.
