Car Stereo
Service Bulletin

Model: XR-U880

No. 227

Subject: No Power When Front Panel Is Installed

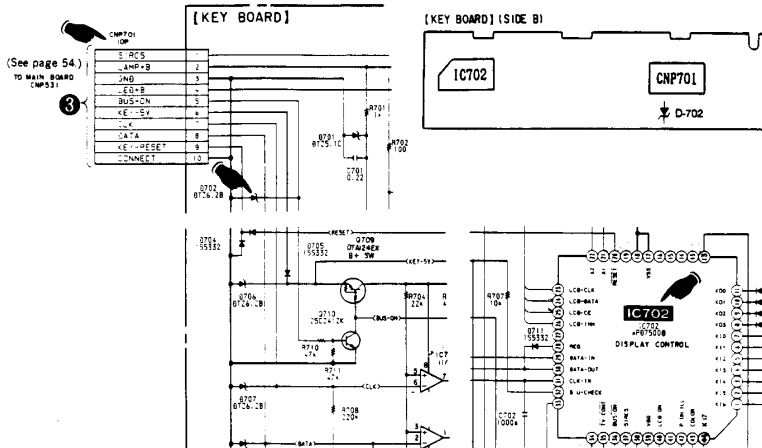
Symptom: (11) The unit will not turn on when the front panel is installed.

Solution: Perform the following modifications on the Key MCB:

1. Replace IC702
2. Replace CNP-701 (Improved; same part number as original)
3. Remove D702
