**Car Stereo
Service Bulletin**

Model: XR-U880

No. 228

Subject: Low Contrast On LCD Display

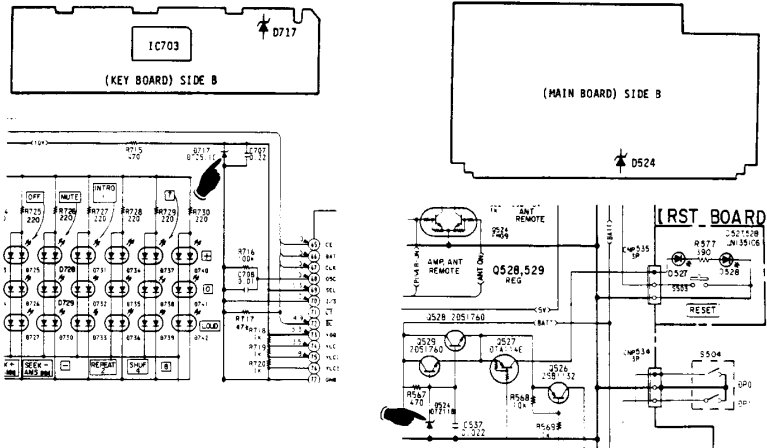
Symptom:
(13) The LCD display has low contrast.

Solution: Perform the following modifications on the Main MCB and the Key MCB:

1. Change D-717 on the Key MCB from DTZ5.1C to DTZ6.2B.
2. Change D-524 on the Main MCB from DTZ11B to RD12ESB2.
