Car Stereo Service Bulletin

Model: XR-7070

No. 234

Subject: Silkscreen Error, IC701 On Key MCB

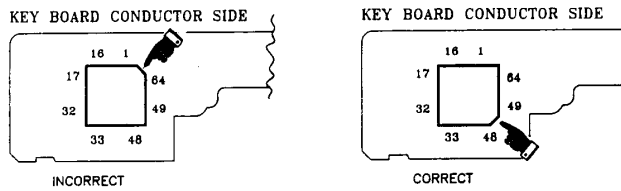
The beveled corner of the silkscreened outline for IC701 is located at the true pin #1 location, but the beveled corner of the IC itself does not indicate pin #1. If a new IC701 is installed with its beveled corner lined up with the beveled corner of the silkscreened outline, the display will not work.

Note the mounting orientation of the original IC and install the replacement IC the same way. If you forget the original orientation, make sure the IC is installed as shown below:
