Car Stereo Service Bulletin

Model: CDX-5040/5080/5180/7520/
7540/7560/7580/U8000

No. 249R1

Subject: Chattering Noise And/Or Skipping At
The Beginning Of The Disc

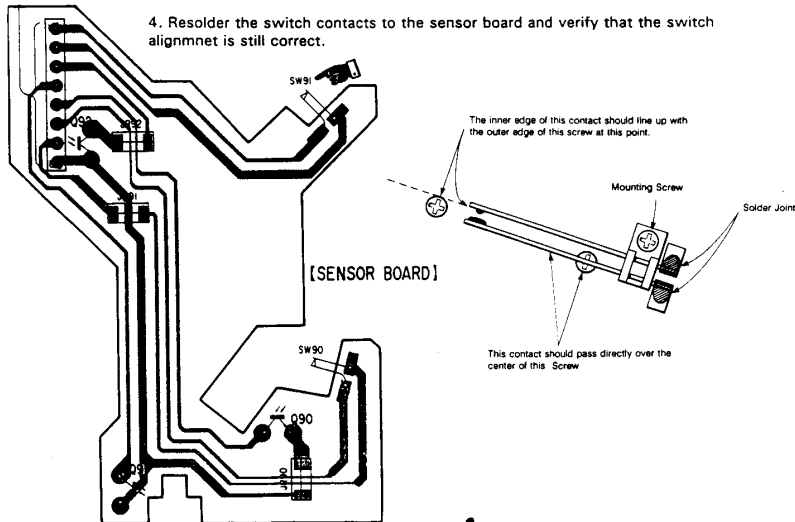
When playing the first track of a disc, a chattering noise may be heard from the CD mechanism. In other instances, skipping may occur when playing the first track on the disc.

Solution: Adjust the limit switch SW-91 on the sensor board as follows:

1. Remove the solder which secures both contacts of the switch to the sensor board, then loosen the screw which is mounted through the plastic body of the switch.
2. Position the switch body so that the contacts are aligned as shown in the drawing.
3. Tighten the screw which was loosened in Step 1. **Do Not Over-tighten!**
4. Resolder the switch contacts to the sensor board and verify that the switch alignment is still correct.
