Car Stereo Service Bulletin

Model: XR-7070

No. 256

Subject: Schematic Correction: +5V and +9V Lines

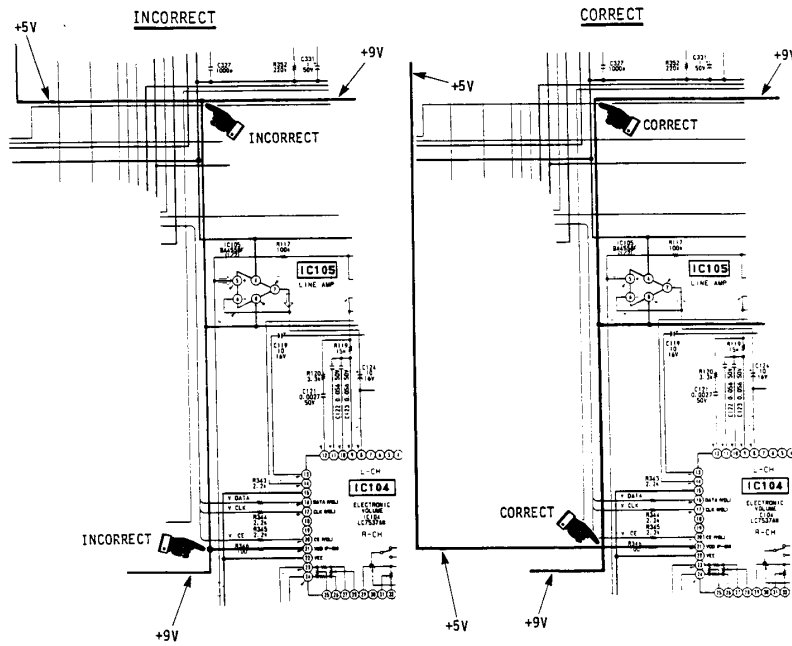
Symptom: (**)
The schematic contains errors with respect to the +5V and +9V lines.

Solution: Correct the schematic in your Service Manual as follows:
