Car Stereo
Service Bulletin

Model: CDX-A55/U300/U300RF/U400/U400D/U500 **No. 259**

Subject: Disc Will Not Load From Magazine Into Mechanism **Date:** September 23, 1992

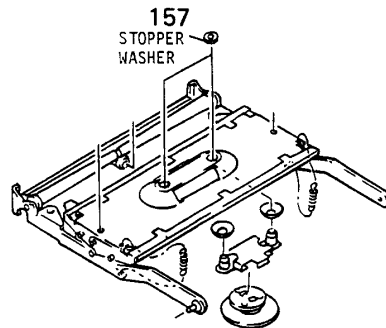
Discs being loaded into the mechanism jam into the chuck plate, preventing proper loading. This is caused by the chuck plate assembly being too low, because one or both of the plastic stopper washers which secure the assembly have become dislodged.

Solution: Secure the chuck plate assembly with improved stopper washers:

DESCRIPTION	PART NUMBER	
	FORMER	NEW
WASHER, STOPPER	3-701-436-11	3-341-752-11
