**Car Stereo
Service Bulletin**

Model: XR-U220

No.262

Subject: Tuner Audio Level May Be Lower Than Audio Level From The Tape and CD

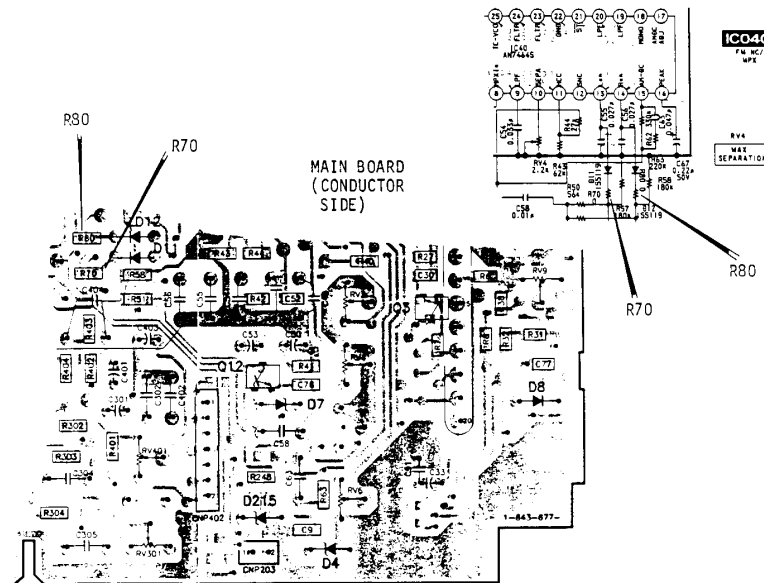
The audio level when listening to the tuner may be lower than the audio level when listening to a tape or CD.

Measure the value of resistors R-70 and R-90 in the tuner section of the Main Board. If the values of these resistors are different than the values specified below, replace them with the correct resistors:

REFERENCE NUMBER	DESCRIPTION	PART NUMBER
R-70, R-80	RESISTOR, 0 OHM	1-216-295-00
