**Car Stereo
Service Bulletin**

Model: XEC-700

No. 269

Subject: Preventing Power Board and DC-DC Converter Failure

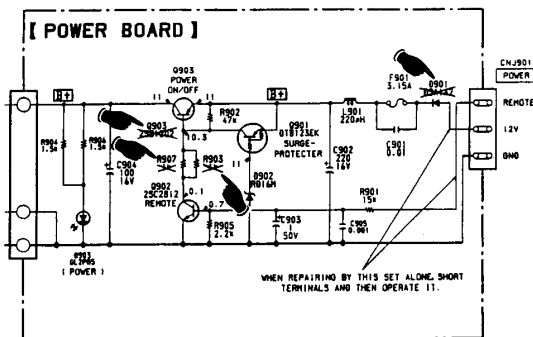
[POWER BOARD]

The unit will not operate; Q-903 on the power board is physically damaged. Also, the DC-DC converter on the Main board may have to be replaced.

Remove Surface Mount Resistors

Replacing the following parts will prevent damage to the Power board and the DC-DC converter:

REF	FORMER		NEW	
	DESCRIPTION	PART NUMBER	DESCRIPTION	PART NUMBER
Q-903	TRANSISTOR, 2SB1202FA	8-729-820-47	TRANSISTOR, 2SB1204T	8-729-015-21
D-901	DIODE, DSA1A2	8-719-928-26	DIODE, ERB83-004	8-719-975-85
R-903	RESISTOR, CARBON MELF, 1K	1-259-995-11	RESISTOR, METAL, 470 OHM 1/2W	1-247-747-11
R-907	RESISTOR, CARBON MELF, 1K	1-259-995-11	RESISTOR, METAL, 470 OHM 1/2W	1-247-747-11
