Car Stereo
Service Bulletin

Model: XES-P1/X1

No. 274

Subject: System Does Not Turn On If Long (18')
Unilink Cable Is Used.

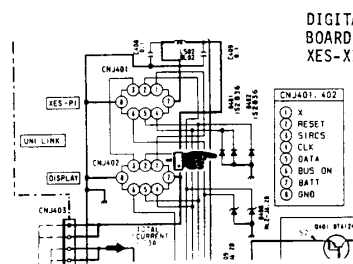
DISPLAY BOARD XES-P1

The system may not turn on if a long (18') Unilink cable is used between the XES-X1 crossover and the display unit or the hideaway unit (or both).

Add RB100A diodes in parallel with D-604 on the XES-P1 DISPLAY board and D-401 on the XES-X1 DIGITAL board.
