Car Stereo Service Bulletin

Model: XR-6500/7130/7150/7180/7200/7280/
7307/7500/7600 **No.283**

Subject: Direction Changes Or Tape Ejects During Play **Date:** May 21, 1993

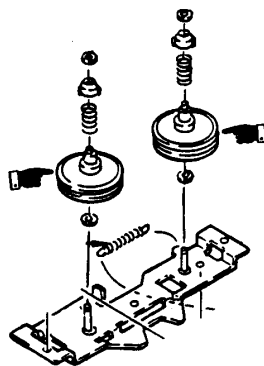
The direction of play may change before the end of the tape has been reached.
Also, the tape may be ejected even though the eject button is not pressed.

Solution: Replace the supply and take-up reel table assemblies with the improved parts shown below.

REF	FORMER		NEW	
	DESCRIPTION	PART NUMBER	DESCRIPTION	PART NUMBER
154	TABLE ASSEMBLY, REEL	X-3344-104-1 OR X-3362-213-1	TABLE ASSEMBLY, REEL	X-3362-213-5
