# Car Stereo Service Bulletin

**Model:** XES-M1

**No.284**

**Subject:** R 135, R 235 Overheat

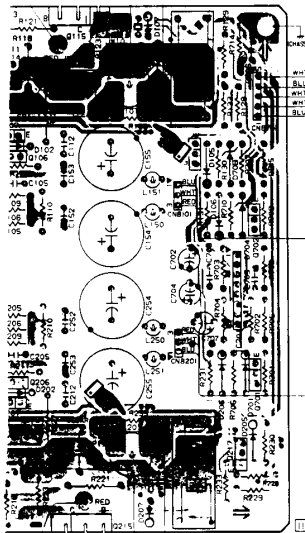
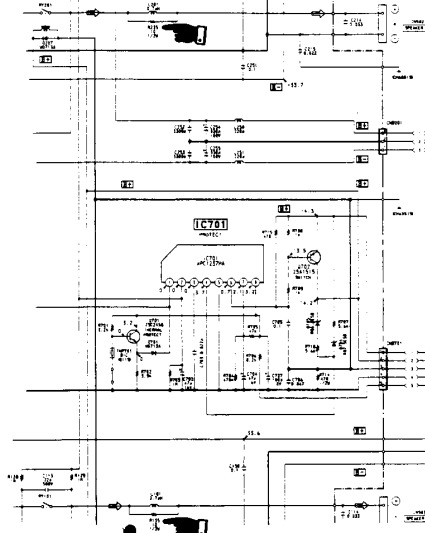
(\*\*) R 135 and R 235 show signs of overheating. Operation of the unit appears to be unaffected.

**Solution:** Replace R 135 and R 235 with parts having a higher power rating.

REF	FORMER		NEW	
	DESCRIPTION	PART NUMBER	DESCRIPTION	PART NUMBER
R 135, R 235	RESISTOR, 10 OHM, 1/2 W	1-247-727-11	RESISTOR, 10 OHM, 2 W	1-212-372-11
