Car Stereo
Service Bulletin

Model: XR-U220/U330

No. 289

Subject: CD Changer Mode Cannot Be Selected

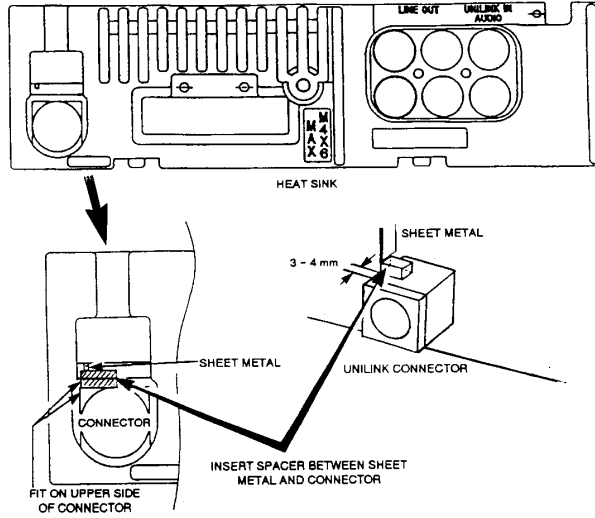
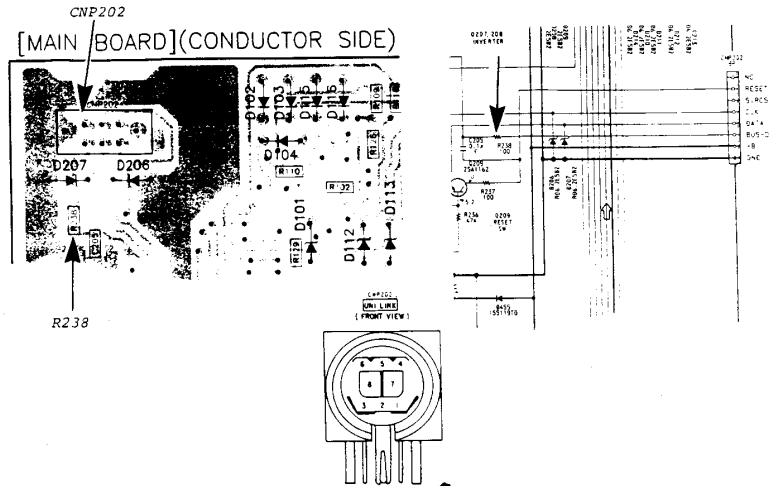
The CD changer mode cannot be selected because the solder of the Unilink connector or R238 is cracked.

Replace R238 (if necessary) and/or resolder the Unilink connector. Prevent the damage from re-occurring by adding a spacer to the Unilink connector as shown below.

1- Remove the heat sink.

2- Apply the spacer to the upper side of the Unilink connector, between the connector and the sheet metal.
