Car Stereo Service Bulletin

Model: CDX-U70/U300/U300RF/U303/U303RF **No. 291**

Subject: CD Changer Generates Reset At Random,
Causing Controller To Shut Off, and CD Changer
Begins Reading Table Of Contents For Each Disc. **Date:** August 12, 1993

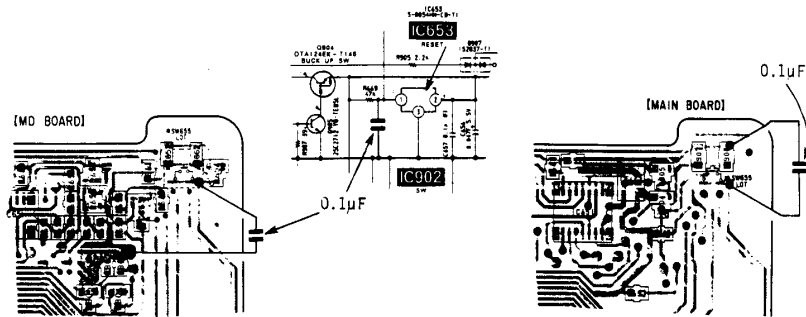
Symptom:
(11) The CD changer generates a reset at random. This causes the CD controller to shut off, even if a mode of operation other than CD mode is being used at the time. The CD changer then reads the table of contents of each disc in the magazine.

Solution: Add a 0.1µF capacitor between pin 1 of IC653 and ground on the Main board or MD board (depending on which board is found in the unit), as shown in the diagrams below.
