# Car Stereo Service Bulletin

**Model:** MDX-U1

**No.** 295

**Subject:** Does Not Eject Discs

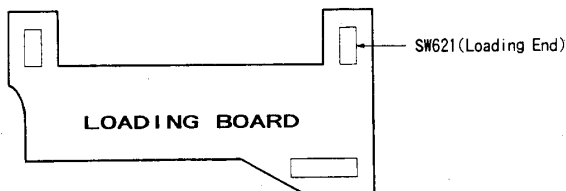
**Original Rack**

Total number of the teeth is the original number less 3 teeth

**Improved Rack**

**Solution:** Replace SW621 on the loading board, and the rack, with the improved parts as shown below.

Apply grease to first 3 teeth
