Car Stereo
Service Bulletin

Model: CDX-U70/U300/U303

No. 298

Subject: Head Unit May Not Turn On If CD Changer Is Connected.

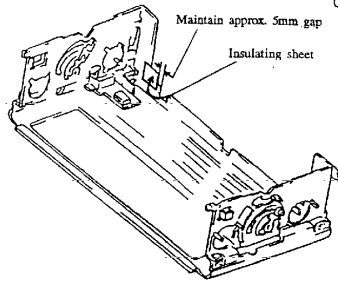
If one of the above mentioned CD changers is connected to a Unilink head unit, the head unit may not turn on.

If this symptom is observed, inspect the Jack flexible board for signs of chafing which may be caused by the flexible board rubbing against the metal chassis. If damage to the flexible board is found, replace it and prevent the problem from re-occurring by adding an insulating sheet to the metal chassis.

If the insulating sheet is unavailable, the repair can be made by applying any insulating tape to the chassis as shown below
