# Car Stereo Service Bulletin

**CSA-14**

**Model:** CDX-U300RF/U500RF; RM-X14      **No. 304**

**Subject:** Displayed Time May Lose Or Gain Several Minutes Per Month.      **Date:** October 19, 1993

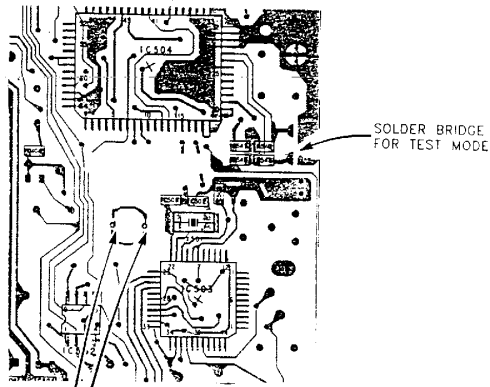
MOUNTING DIAGRAM

**Symptom:**  
(13) The time shown on the display may lose or gain several minutes per month.

- 1- Change C508 and C509 from 22 pF to 10 pF.
- 2- Add a trimmer capacitor as shown in the drawing.

- 1- Put the unit in the test mode by adding a solder bridge as shown (this solder bridge grounds pin 27 of IC504).
- 2- Adjust the trimer capacitor so that the frequency measured on pin 40 of IC504 is 16.384 KHz.
- 3- Release the test mode by removing the solder bridge.

MOUNT TRIMMER  
CAPACITOR HERE
