Car Stereo
Service Bulletin

Model: CDX-A35RF/U70/U303

No. 306

Subject: No Operation

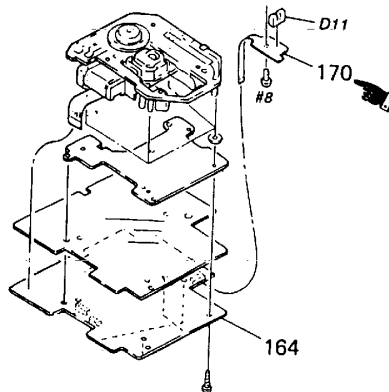
The CD changer does not operate. This may be caused by newer EHS flexible boards which are made of phenolic paper, and which may allow the position of photosensor diode D11 to shift. Consequently, the microcontroller cannot detect movement of the EV gear.

If this problem occurs in units equipped with the phenolic paper type EHS flexible board, replace it with the original type flexible board, which is made of epoxy resin.

REF	DESCRIPTION	PART NUMBER
170	EHS FLEXIBLE BOARD	1-637-483-11
