**Car Stereo
Service Bulletin**

Model: CDX-U606; XES-P1/X1

No. 314

Subject: No Audio After AMS Or Disc Change

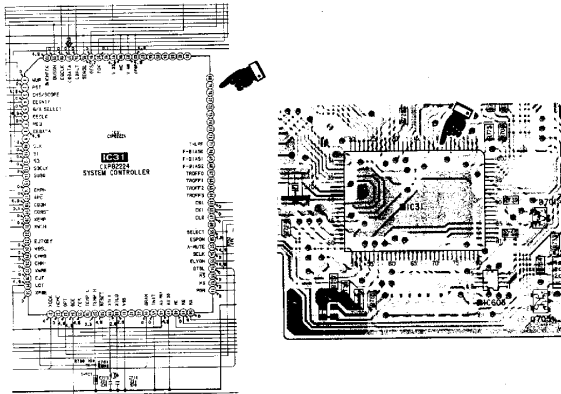
[SERVO BOARD]

If the CDX-U606 is used in a system which also includes the XES-P1 and XES-X1 the audio may cut out after AMS'ing or after changing discs.

If this symptom occurs in the above mentioned system configuration, replace CPU IC31 on the **CDX-U606 Servo board** with an improved version.

REF	DESCRIPTION	PART NUMBER
IC31	IC, CXP82224-013Q	8-752-853-08
