Car Stereo Service Bulletin

CSA-14

Model: CDX-5040/5080/7520/7540/7560/7580; **No. 318**
EXCD-40

Subject: Discs Jam During Loading.

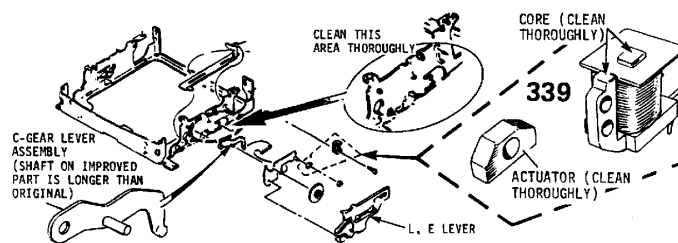
During the loading process, the chucking plate clamps as soon as the disc is inserted, instead of waiting until the disc has been pulled in completely. As a result, the disc jams into the chucking plate. Once this occurs, the shaft on the C-gear Lever Assy. gets stuck between the CD chassis and the L,E Lever, and the jamming will almost always re-occur repeatedly until the shaft is manually placed back into its normal position.

1- Using isopropyl alcohol, *thoroughly* clean any grease from PM901 (both the core and the actuator) and the surrounding area of the CD chassis. The layer of grease found on these parts may be so thin that it cannot be seen; nevertheless it can cause the actuator to stick to the core, so be diligent when cleaning.

2- Replace the original C-gear Lever Assy. with an improved type which has a longer shaft. If for some reason the unit pre-clamps even after the grease has been cleaned, the improved lever will eliminate the need to manually re-seat the lever, and the customer can simply re-insert the disc without jamming.
