Car Stereo Service Bulletin

DTX-10

No. 319

Subject: Audio Dropouts Caused By High Or Low

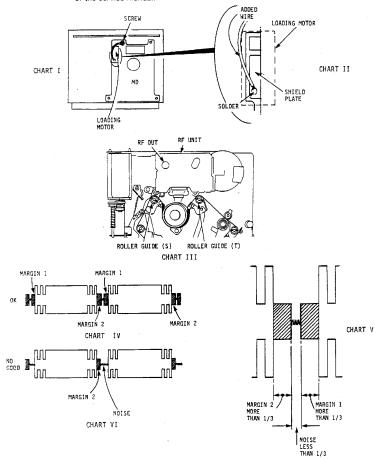
b- If Margin 1 does not appear on the oscilloscope, rotate Roller Guide(S) counterclockwise. If Margin 2 does not appear on the oscilloscope, rotate the Roller Guide(T) clockwise. Adjust the guides so that the level of noise shown in Chart V is as low as possible.

c- Play test tape TY-7231 and adjust the guides so that the RF waveform conforms to the Tape Path Adjustment procedure shown in supplement # 2 of the service manual.
