**Car Stereo
Service Bulletin**

Model: XA-18

No. 321

Subject: Eliminating Pop Noise.

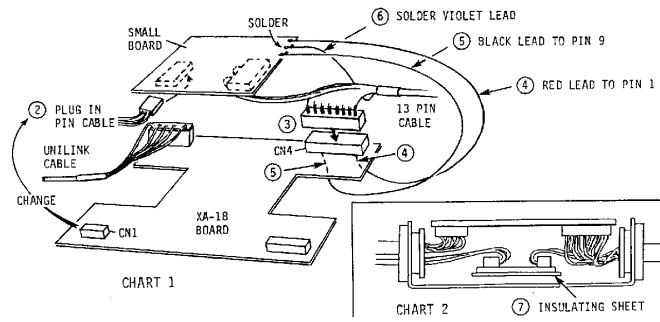
A pop noise may be heard when changing discs.

Solution: Add a mute circuit board as shown below.

- Procedure:**
- 1- Open the case and remove the 13-wire cable from CN4 and CN3 on the XA-18 board.
 - 2- Remove the plug from CN1 on the XA-18 board and plug it into the connector on the Mute board.
 - 3- Plug the 9-pin connector (supplied with Mute board) into CN4 of the XA-18 board.
 - 4- Solder the red wire from the Mute board to pin # 1 of CN4.
 - 5- Solder black wire from the Mute board to pin # 9 of CN4.
 - 6- Solder the violet wire of the 13-wire cable supplied with the Mute board to the land in between the lands for the red and black wires on the Mute board.
 - 7- Attach the cable clamp to the 13-pin cable and install in the case as shown in chart II.
