Car Stereo
Service Bulletin

Model: XR-U220/U330/U550/U660 **No.** 322

Subject: Loses Memory Presets; Clock Resets To 1:00 **Date:** May 13, 1994

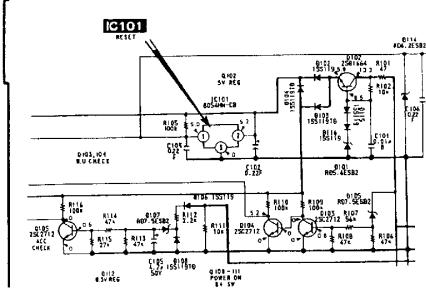
XR-U220/U330

Symptom:
(13) The memory presets are lost, and the clock resets to 1:00.

Solution: Replace reset IC101 on the Main board for the XR-U220 and XR-U330, or IC504 on the Main board for the XR-U550 and XR-U660.*
