Car Stereo  
**Service Bulletin**

**CSA-14**

**Model:** CDX-5060

**Subject:** No Functions Due To Main Board/ Display Board  
Incompatibility.

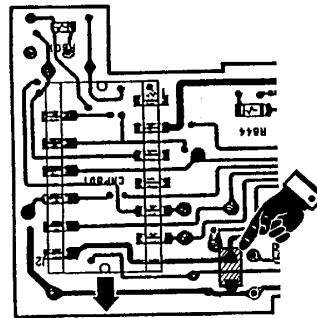
DISPLAY BOARD (Side B)

After replacing the Main Board or the Display Board, the unit may not respond to any function buttons.

This problem may be caused if a **Main Board** having a silk-screened suffix of -12 is connected with a **Display Board** having a silk-screened suffix of -11. In this case, normal operation can be restored by adding a jumper resistor to the -11 Display Board as shown below.

REF	DESCRIPTION	PART NUMBER
JR801	JUMPER RESISTOR, 0 OHM	1-216-295-00
