Car Stereo
Service Bulletin

CSA-14

Model: CDX-U303/U303RF/U404/U606 **No.** 324
Subject: One Disc Is Not Ejected **Date:** May 27, 1994

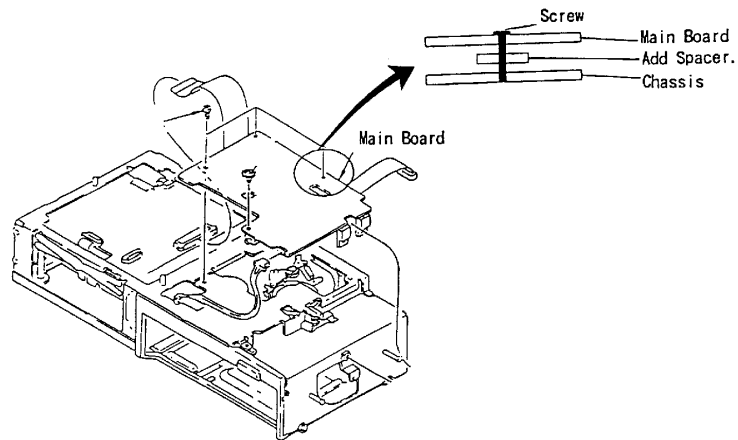
One disc may remain in the mechanism when the magazine is ejected in response to a "RESET" or "E-99" message on the controller's display. (The disc can be ejected if an empty magazine is re-loaded into the mechanism and the reset button on the controller is pressed).

While playing, vibrate the rear of the magazine up and down several times with your finger. In case RESET or E-99 is indicated, add a spacer between Main Board and Chassis.

When a disc is changed while pressing EV Ass'y by your finger and the motor runs idle, change EV Gear Ass'y. If the motor stops, it is not necessary to change the EV Gear Ass'y.

- 1- Vibration of the vehicle causes the magazine to shake, resulting in the magazine lock lever being pushed down. To verify this condition, manually move the rear of the magazine up and down several times while playing a disc. If "RESET" or "E-99" appears on the controller's display, add a spacer between the Main board and the chassis as shown.

- 2- The EV gear assembly slips. To verify this condition, while playing a disc select a higher numbered disc (the higher numbered disc will cause the elevator to move upward rather than downward), and manually prevent the elevator from moving. If the elevator motor stops rotating completely, the EV gear assembly is O.K. If the elevator motor continues to run, replace the EV gear assembly.
