Car Stereo
Service Bulletin

Model: CDX-900

No. 331

Subject: Eliminating Alternator Noise.

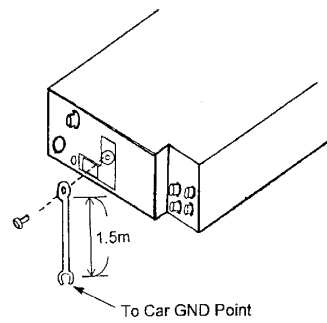
Alternator noise is heard from the speakers, particularly in European-manufactured vehicles using floating ground systems.

Improved the ground of the unit by adding a grounding strap between it and a good chassis ground point on the vehicle. If necessary, use the screw listed below to connect the ground strap to the vehicle's chassis.
