Car Stereo
Service Bulletin

CSA-14

No. 334

Subject: Skipping When Outer Tracks Are Played.

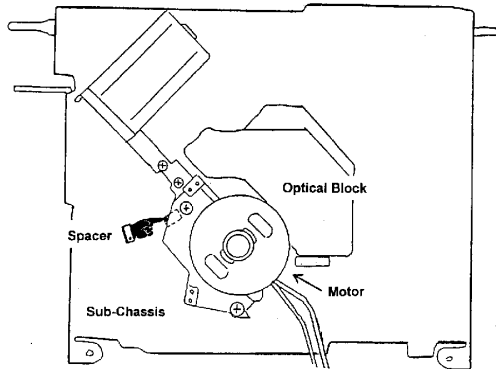
The customer may complain that skipping occurs when outer tracks of discs are played. This may occur if the mechanism sub-chassis is bent, which makes it more difficult to maintain proper focus at the outer portions of discs.

Solution: If the customer complains of this problem, add a spacer to the sub-chassis as shown below.

REF	DESCRIPTION	PART NUMBER
-	SPACER	2-626-870-21
