Car Stereo
Service Bulletin

Model: CDX-U8000

No. 335

Subject: Preventing Damage To Flex Cables.

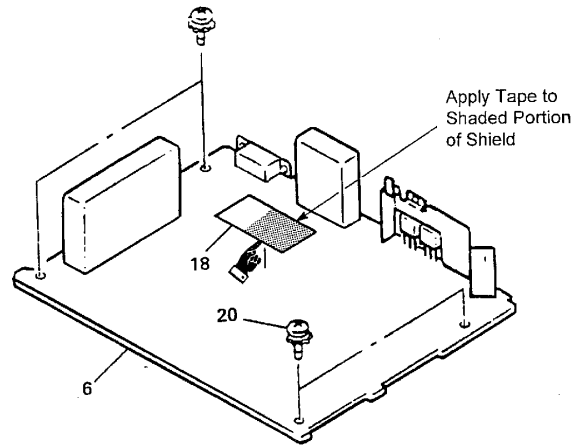
The shield plate mounted on the Main board may contact the flex cables between the Main board and the RF board, causing the cables to be damaged.

Solution: Add tape to the shield plate as shown below.
