Car Stereo Service Bulletin

Model: XR-U500/U700/U800

No. 344

Subject: Noise Heard From Speakers When Using Cellular Phone.

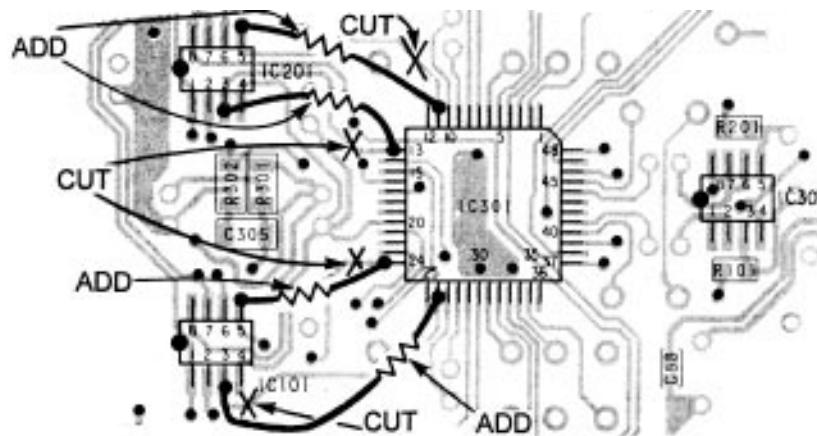
Noise may be heard from the speakers when using a cellular phone.

If the customer complains of this problem, implement the following changes on the Main board.

- 1- Cut the traces as indicated by the "X".
- 2- Add 33K resistors between the following points:
 - IC301 pin 11 and IC201 pin 5
 - IC301 pin 13 and IC201 pin 3
 - IC301 pin 24 and IC101 pin 5
 - IC301 pin 26 and IC101 pin 3
