Car Stereo Service Bulletin

Model: CDX-900/5060/5070/5260/5270/5460/
5470; EXCD-60

No. 345

Subject: No Loading Or Eject

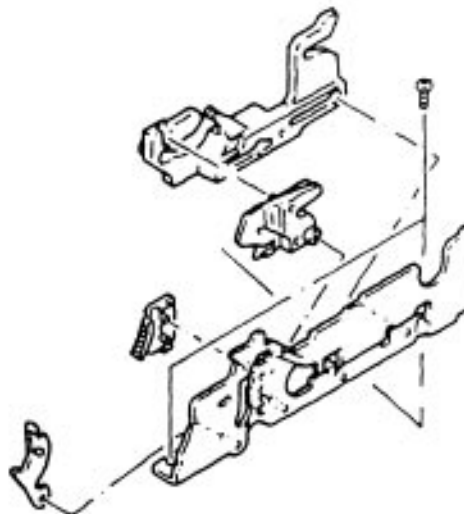
Discs may not load or eject.

This problem may be caused by the ST lever becoming dis-engaged from the sliding arm mounted on the mechanism top cover. If this is the case, replace the mechanism right side parts with the improved parts kit shown below.

REF	DESCRIPTION	PART NUMBER
-	CHASSIS (R) ASSY.	A-3252-581-A
