# Car Stereo Service Bulletin

**Model:** GEN-CAR

**No.** 346

**Subject:** Preventing Recurring Damage To Tuner Pack.

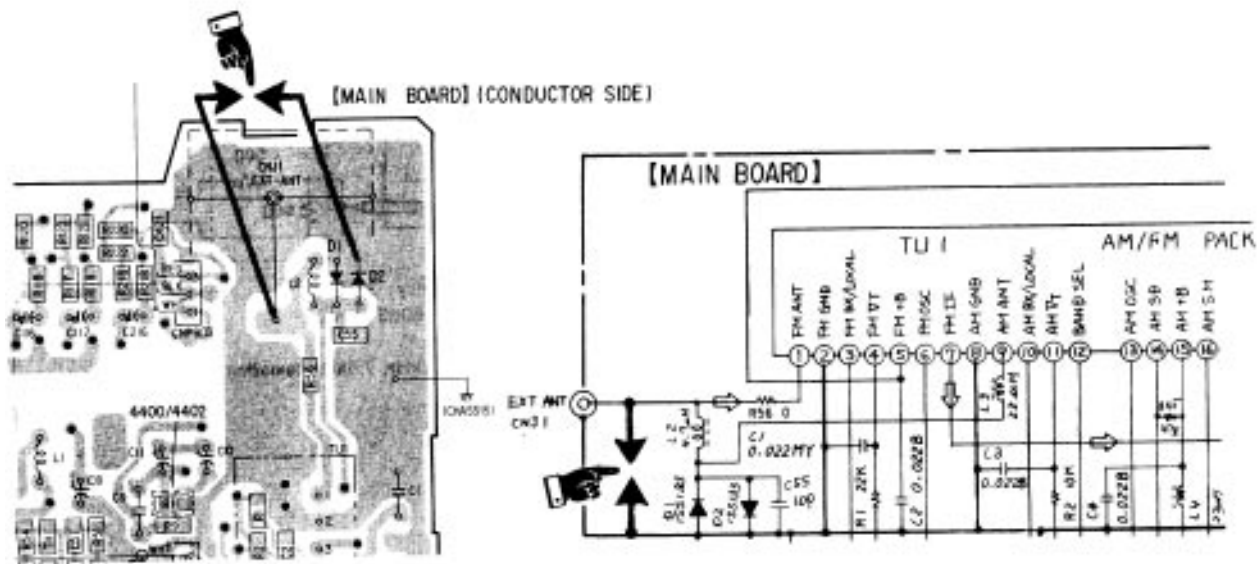
The customer may complain that the tuner sensitivity has become poor, which is cured by replacing the tuner pack. At a time subsequent to the repair, the customer complains that the sensitivity has become poor again.

Example shown is for XR-4400; other models are similar.

**Solution:** Replace the tuner pack. Prevent recurring damage to the tuner pack by adding a discharge gap across the antenna input lead and ground.

REF	DESCRIPTION	PART NUMBER
-	DISCHARGE GAP	1-519-504-11
