Hi-Fi Products
Service Bulletin

Model: CDP-510/910/505ESD

No. 25

Subject: Intermittent No Eject

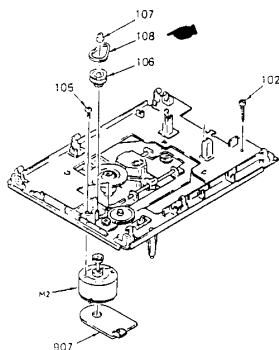
Loading tray is intermittently not ejected.

Note: Diagram shown is for the CDP-510.

Solution: Replace the driving belt with the new one as shown:

Model	Ref. No.	Description	Part Number	
			Former	New
CDP-510	108	Driving Belt	4-917-548-01	4-917-548-02
CDP-910	206	Driving Belt	4-917-548-01	4-917-548-02
CDP-505ESD	206	Driving Belt	4-917-548-01	4-917-548-02
