Hi-Fi Products
Service Bulletin

Model: RM-E7

No. 29

Subject: Upgrade From A 44-Key To A
91-Key Program

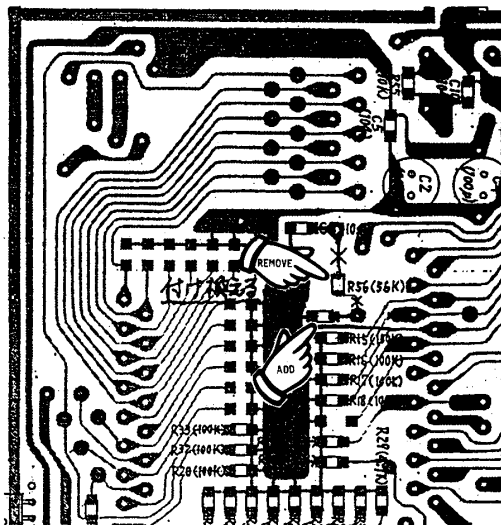
The remotes that were included with the preamps of serial numbers up to 800251 only had a 44-key programmable format and only the inside keys could be programmed.

Solution: To upgrade to a 91-key program, move R56 (56K) from its present position to the unoccupied R28 position. Leave the R56 position open. Be careful with the plastic tabs when opening the cabinet.
