Hi-Fi Products  
Service Bulletin

**Model:** CDP-68/307ESD/750/950

**No.** 32

**Subject:** No Chucking Operation

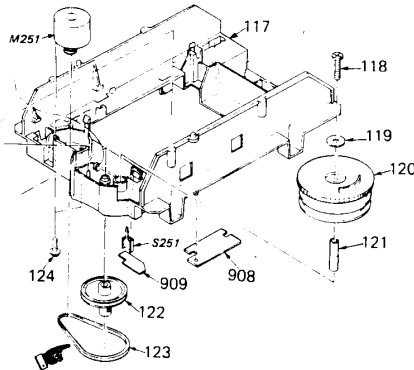
During the loading cycle, the disc will not be completely chucked. The optical section may swing upward only partially or perhaps not at all.

**Cause:** This is caused by the drive belt slipping.

**Solution:** Replace the former drive belt with a newer version drive belt. The part number is listed below:

Ref. No.	Description	Part Number	
		Former	New
123	Belt	4-917-522-01	4-917-522-02
