Hi-Fi Products  
**Service Bulletin**

**Model:** TC-K55/K61/K75/K81/U60/U70

**No.** 35

**Subject:** Capstan Motor Replacement

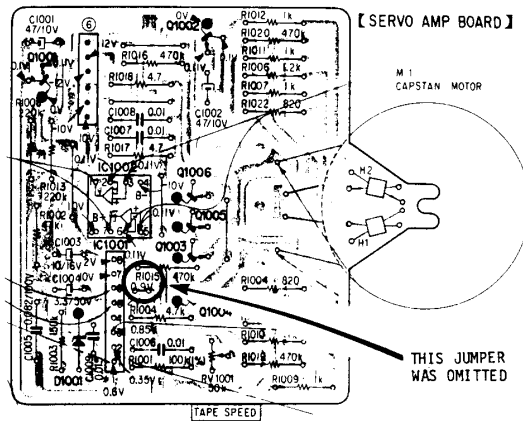
After installing a new Capstan Motor (which includes the Servo PCB), the motor does not start rotating.

**Cause:** A jumper connection on the Servo PCB is missing.

**Solution:** Bridge the solder pads on Pin 6 at IC-1001 as shown below:
