Hi-Fi Products
Service Bulletin

Model: TA-N77ES

No. 57

Subject: Relay Noise Is Heard

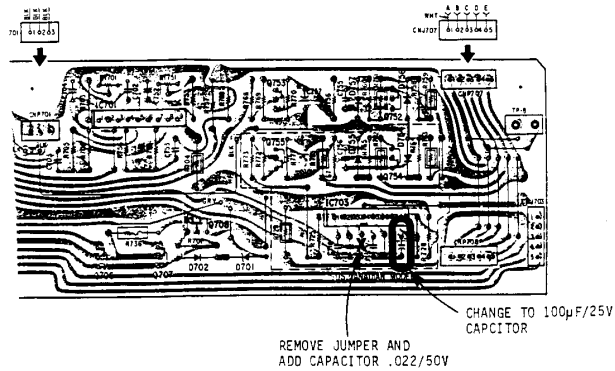
If customer complains of relay noise or chatter, perform the following:

Cut the connection from pin 3 of IC703 and ground and add a .022 μ F/50V capacitor between these points. Also change the value of C716 from a 470 μ F/10V to 100 μ F/25V.
