Hi-Fi Products
Service Bulletin

Model: STR-GX9ES

No. 64

Subject: Noise In Output

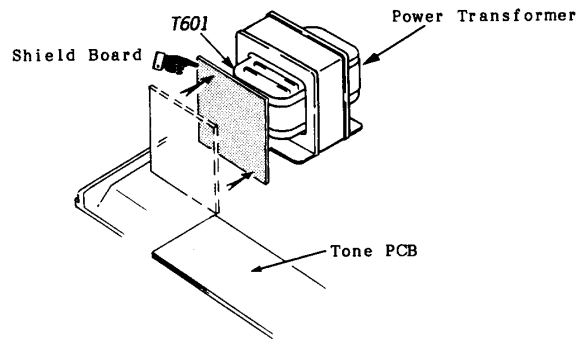
Tone PCB picks up hum from the power transformer.

Solution: Please add a shield board to the transformer as shown:

Description	Part Number
Shield Board	T-9985-208-1
