Hi-Fi Products  
Service Bulletin

**Model:** CFD-D77

**No.** 68

**Subject:** Mechanical Noise During CD Play

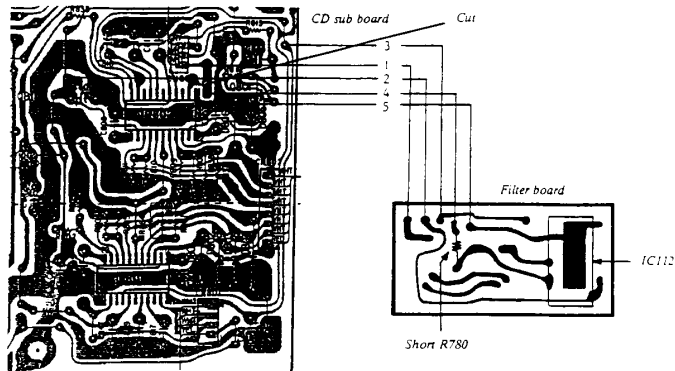
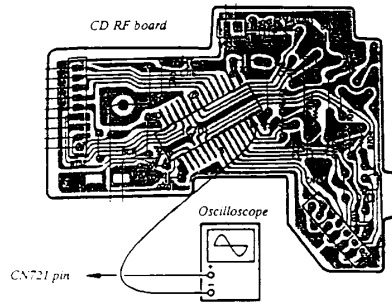
CFD-D77  
(CD SUB-BOARD)

Resonance within the MD chassis assembly causes the MD cover to vibrate and produce mechanical noise.

Connect the filter board to the CD sub-board with five wires as indicated by the following table.

Mounted PCB, Filter	1	2	3	4	5
CD Sub-Board	CN803 Pin 3	C809	C801	IC802 Pin 2	IC802 Pin 1
