Hi-Fi Products
Service Bulletin

Model: D2, D4, DT4

No. 85

Subject: Rack and Motor Assembly Replacement **Date:** September 15, 1989

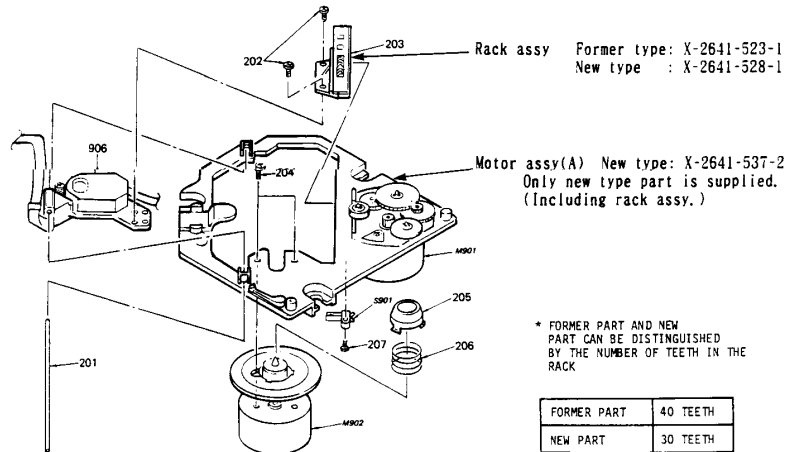
Old type of rack and motor gears may bind causing skipping or no play.

Solution: The rack and motor assemblies should be replaced with the new type of rack and motor assemblies listed below:

Note: There is no interchangeability between old and new type parts. Therefore, when replacing the motor assembly (A), the new type of motor and rack assembly must be used.

These parts are supplied together under one part number.

The new rack assembly is also available separately, but must only be used with the new motor assembly.
