Hi-Fi Products
Service Bulletin

Model: MDR-IF5K

No. 89R1

Subject: Improvement of Signal to Noise Response

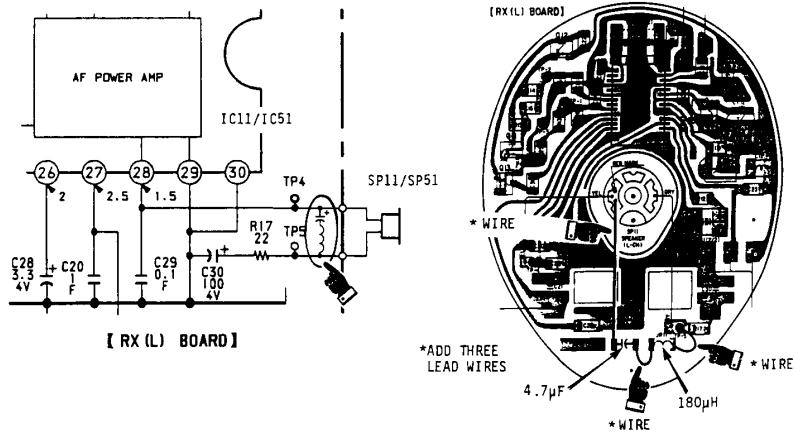
On Headphones

Symptom:
(54)

A high level of residual noise is present. This hissing is most noticeable during quiet passages.

Add a capacitor and a coil to both sides of SP11/SP51.

Description	Part Number
Chip, Tantalum Elect 4.7 μ F/4V	1-135-151-21
Chip, Inductor 180 μ H	1-410-657-21
