# Hi-Fi Products Service Bulletin

**Model:** STR-GX10ES

**No.102R2**

**Subject:** Tuner Bleedthrough Into  
Other Modes

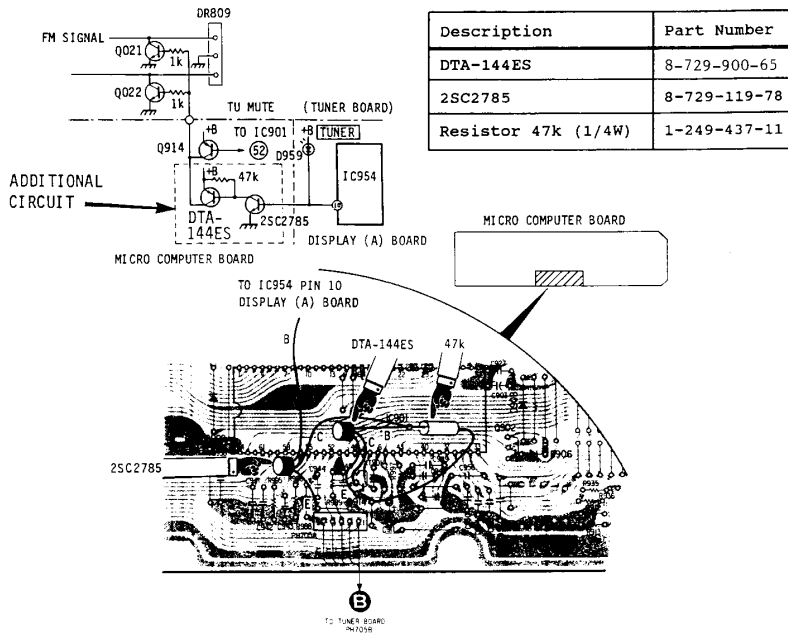
**Symptom:**  
(54) If customer complains of FM bleedthrough, please add the following muting circuit:

**Solution:**
