Hi-Fi Products
Service Bulletin

Model: STR-VX5

No. 109R1

Subject: Coil Data For T901 and T902

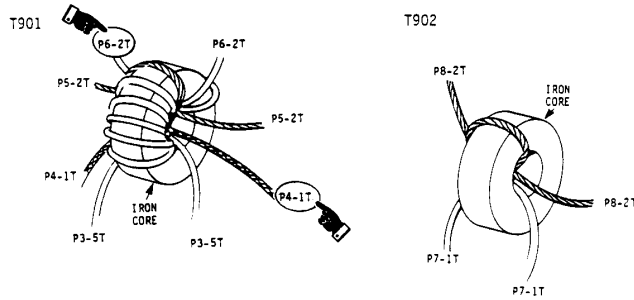
The service manual lists the part number for the iron core of these two transformers. They are not available wound. They must be wound by hand.

Solution: The number of turns of wire and the gauge is listed below:

Wire Number	Turns	Description
P-3	5T	Polyurethane 0.40mm Diameter
P-4	1T	(Green) AWG28
P-5	2T	(Red) AWG28
P-6	2T	(White) AWG28
P-7	1T	(White) AWG22
P-8	2T	(Red) AWG24
