Hi-Fi Products
Service Bulletin

Model: TA-E1000ESD

No.113

Subject: Clicking Noise Is Heard When Changing Inputs (Sources)

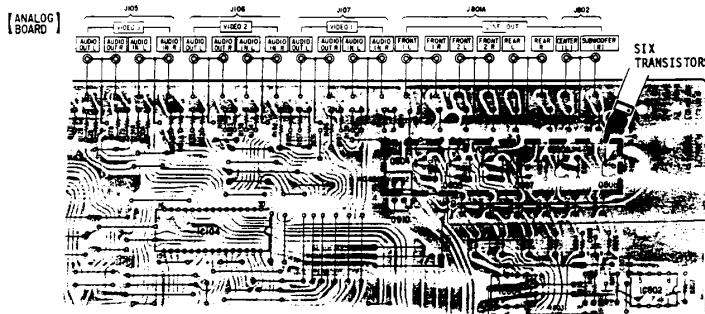
If the customer complains of hearing clicking noise through the speakers when changing inputs, perform the changes listed below. This is caused by mismatched muting transistors.

Solution: Replace the muting transistors (Q801/804-808) which are now 2SC3622 and 2SC2878B, and swap the collector and emitter leads when installing the 2SC2878B.
