Hi-Fi Products  
**Service Bulletin**

**Model:** SEN-190 (HST-190)

**No. 120**

**Subject:** No Sound or Oscillation During  
Tape Playback

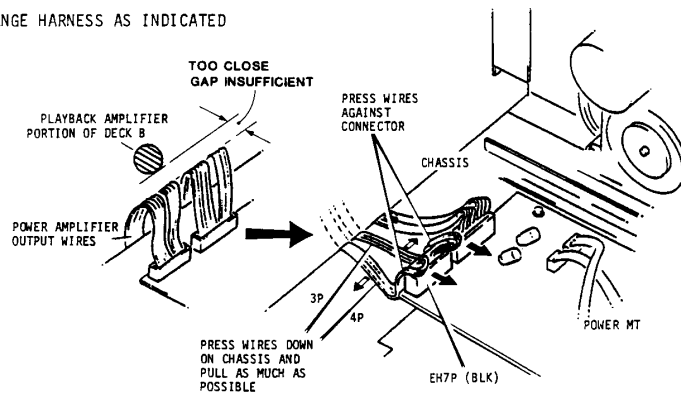
**Cause:** The power amplifier output wires are too close to the Playback amplifier portion of Deck B, causing inductive coupling.

**Solution:** Reroute the wires so that they are as far away from this position of the PCB as possible.

ARRANGE HARNESS AS INDICATED
