Hi-Fi Products
Service Bulletin

Model: TA-AV480

No. 128

Subject: AC Line/Click Noise

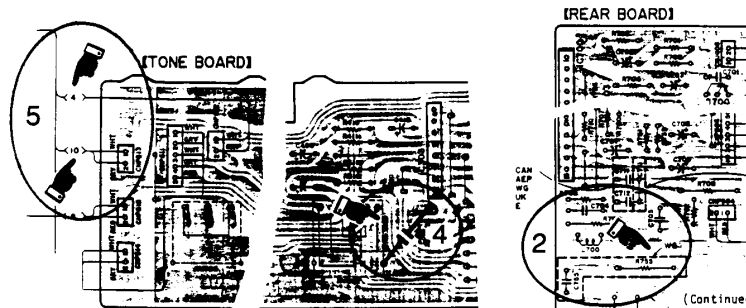
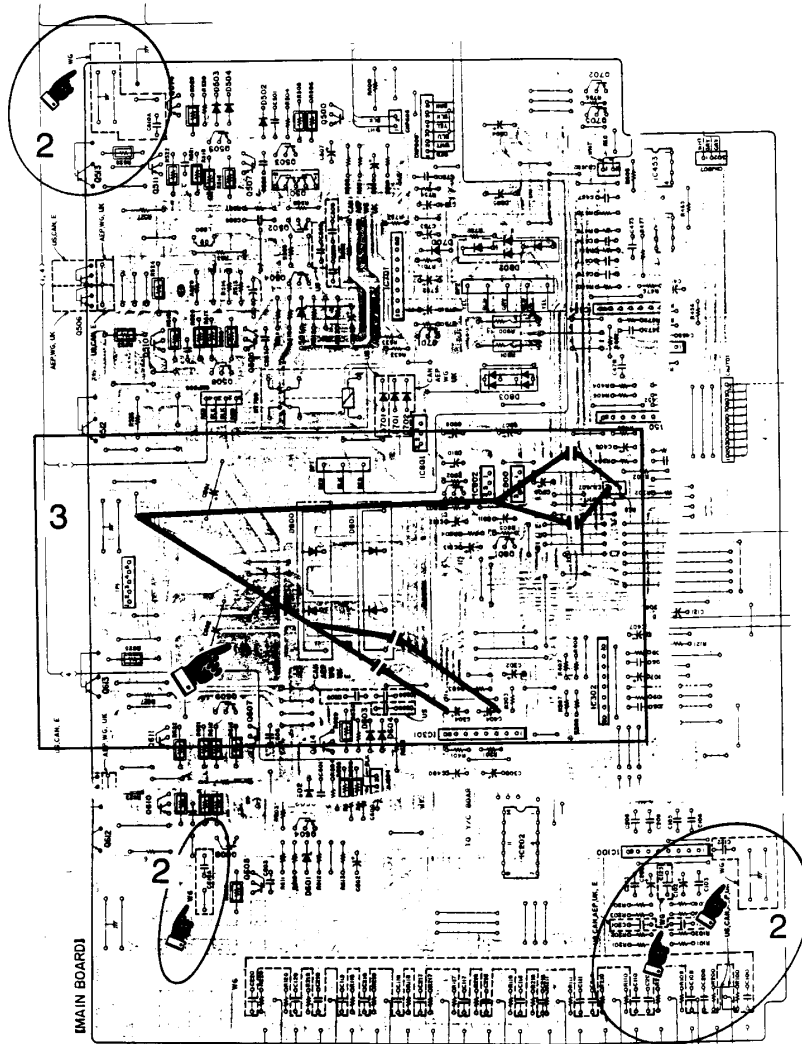
Symptom:
(54)

There is a click noise in the speaker output when switching other devices on the same AC line On or Off.

- Solution:**
1. Check whether the tone board contains the capacitors C317 and C417. If it does not, install them.
 2. Add the following components, including the groundings with the chassis.

Board	Component
Main	C510A, C610A, C122, C123
Rear	C755, R755

3. Add four 0.022uF capacitors (P/N 1-161-494-00) on the main board.
4. Add a 0.022uF capacitor (P/N 1-161-494-00) on the tone board.
5. Replace cables 4 and 10 between the tone board (output) and the main board (power amp input) by shielded wires, and connect the shielding also to the ground of the tone board. The part number for a 38 ft. roll of two conductor shielded wire is 9-919-538-00.
