Hi-Fi Products
Service Bulletin

Model: TA-F210

No. 133

Subject: Loudness Effect Not Sufficient

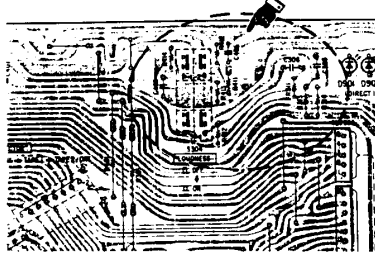
[FUNCTION BOARD]

If the loudness effect is not sufficient when the loudness button is pressed, replace the following parts.

| Ref. No. | Description | | Part Number |
|---|---|---|---|
| R311, R411 | Resistor, 22k 1/4W | Resistor, 10k 1/4W | 1-247-725-11 |
| R312, R412 | Resistor, 100k 1/4W | Resistor, 27k 1/4W | 1-249-463-11 |
| R314, R414 | Resistor, 10k 1/4W | Resistor, 4.3k 1/4W | 1-247-846-11 |
| C306, C406 | Capacitor, 820pF | Capacitor, 1200pF | 1-164-086-11 |
| C305, C405 | Capacitor, 0.022uF | Capacitor, 0.047uF | 1-136-161-00 |
