Hi-Fi Products  
Service Bulletin

**Model:** TC-RX70

**No.** 140

**Subject:** No Power - R725/R726 Open

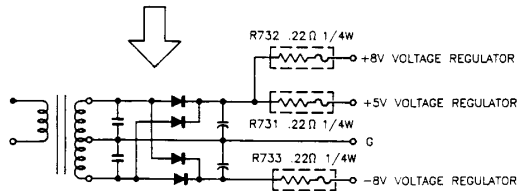
Fig. 1

R725/R726 opens due to the rush current.

**Solution:** If this occurs, modify the circuit as follows:

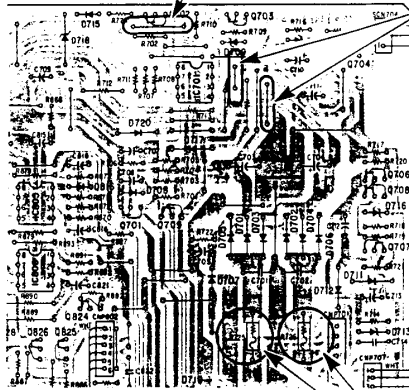
Fig. 3

【MAIN BOARD (CONDUCTOR SIDE)】

Install a 0.22Ω fusible resistor  
instead of a jumper wire.  
(Remove JW9.)

Install a 0.22Ω fusible resistor  
instead of a jumper wire.  
(Remove JW5/JW7.)

Install a jumper wire instead of a  
0.22Ω fusible resistor.  
(Remove 0.22Ω.)
