Hi-Fi Products
Service Bulletin

Model: STR-AV920/AV1020

No. 142

Subject: Service Manual Correction - Q707

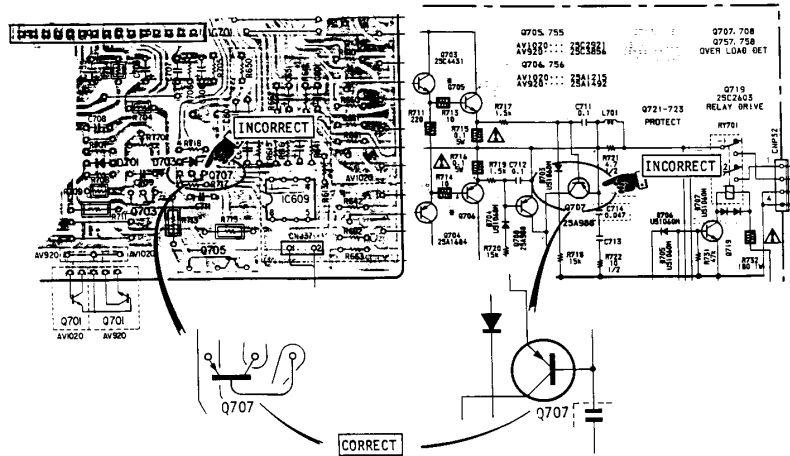
In both the schematic and board layout portion of the service manual, the base and emitter of overload detector transistor Q707 is incorrectly illustrated.

Solution: The Base and Emitter of Q707 should be reversed. Please correct your service manual as indicated below:
