Hi-Fi Products
Service Bulletin

Model: STR-AV920/AV1020

No. 147

Subject: Service Manual Correction -
IC701 Pin Out

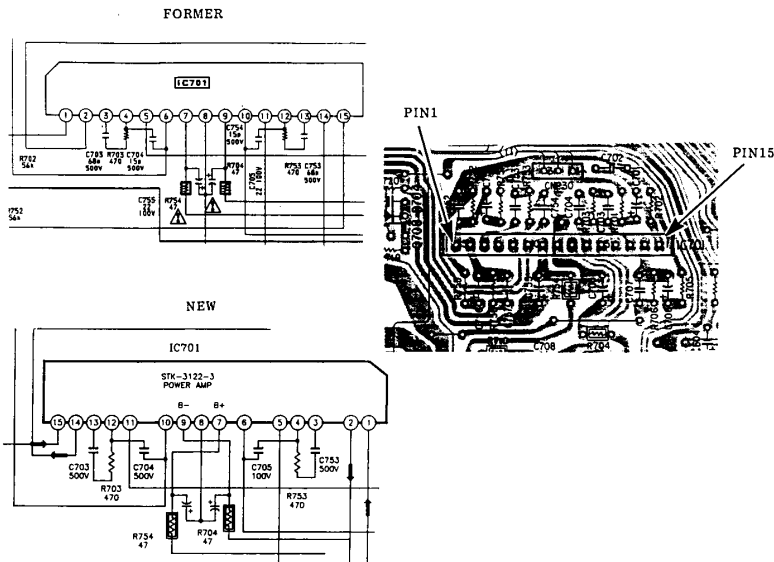
IC701 is shown reversed in the schematic diagram in the service manual. Pins 1 to 15 are listed in the wrong sequence, and B+ and B- are on the wrong inputs when the IC is shown correctly installed.

Solution: Please make the following corrections on page 20 of your service manual, and in the schematic on page 17.
